Submission to:
Royal Commission into Violence, Abuse, Neglect
and Exploitation of People with Disability 2022

Dean
Homicki
for Stæbl
Academy
Reviews:

Ignorance, Obstacles, & Neglect: Access to the built environment for persons with a disability

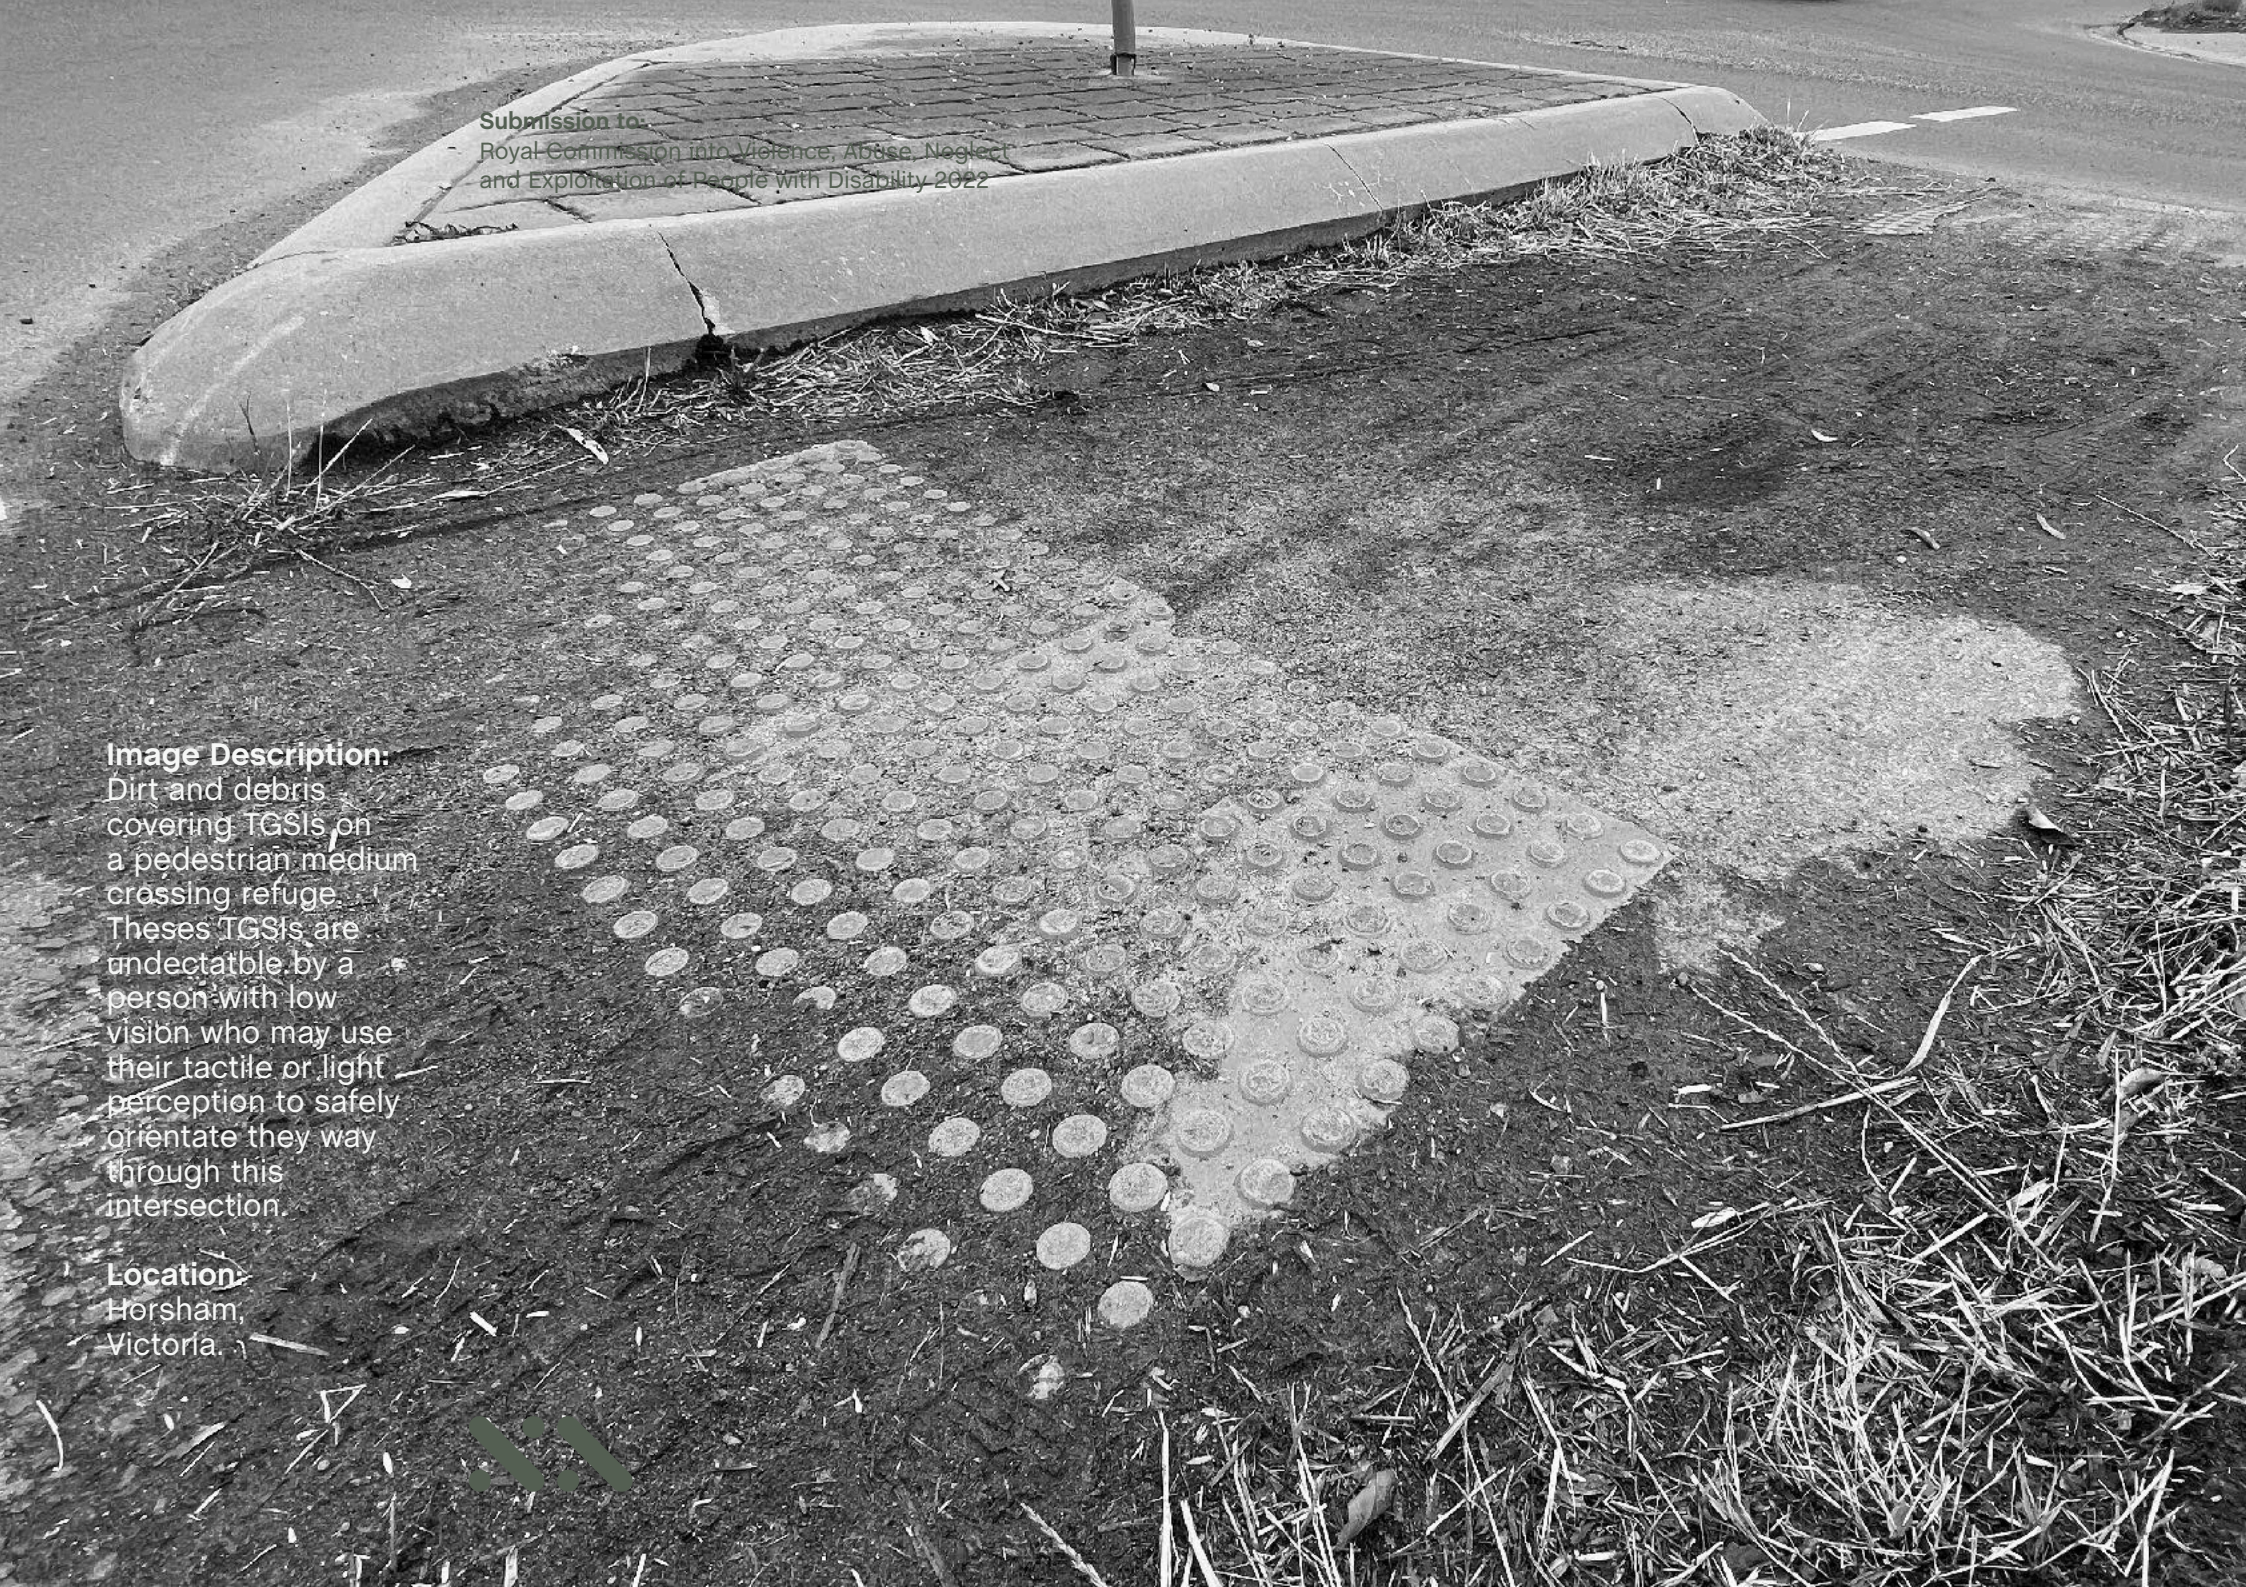
Location:

Dirt and debris covering TGSIs on a pedestrian medium crossing refuge. These TGSIs are undetectable by a person with low vision who may use their tactile or light perception to safely orientate they way through this intersection.

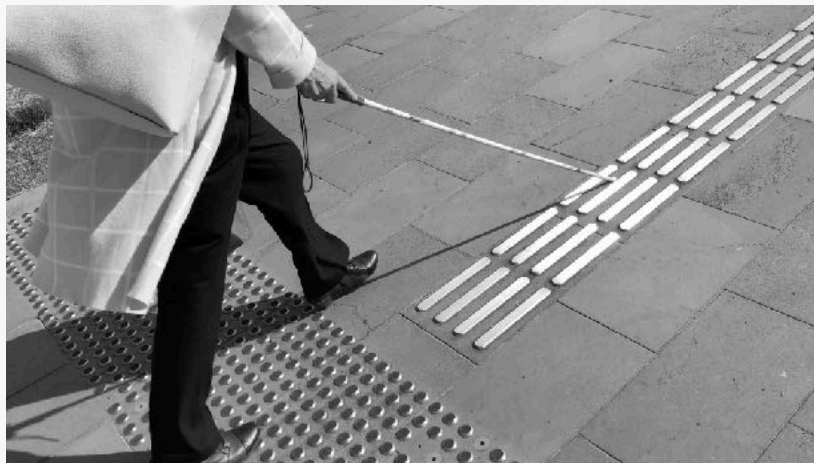
Example 1 Length: 1:37 mins

Orientation & Mobility for a person with low vision using a white cane

This is the story of Faye. Faye experiences low vision and sometimes uses a white cane to navigate the built environment in her local area. Faye is a trained user of Tactile Ground Surface Indicators (TGSIs), which supply her with guidance, orientation and mobility.

This video submission is about how Faye using TGSIs to move from the perimeter of a building, across a busy road to where she continues her journey on the side. This is an example of safe and independent mobility provided through the correct use of mobility products (TGSIs) and their application, allowing for barrier-free access along the path and a direction of travel in a built environment.

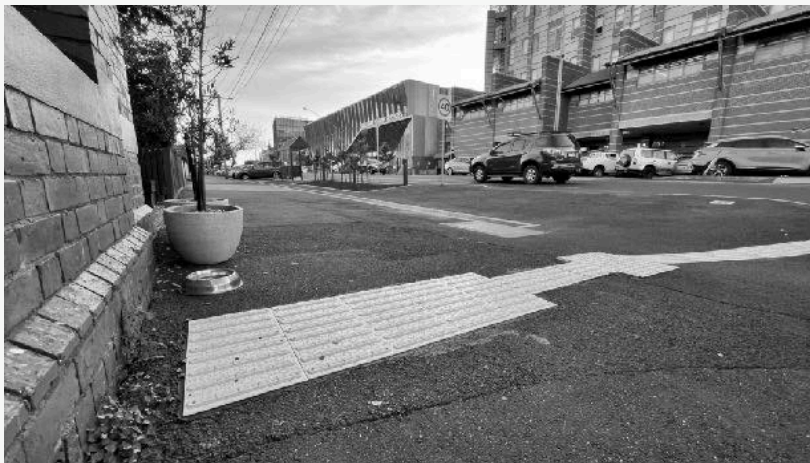
Example 2 Length: 4:30 mins

Pot plants and mobility along a building line

Obstacles that are voluntarily placed along a building line into an accessible path of travel positioned near entrances to premises or over accessible orientation and mobility aids like Tactile Ground Surface Indicators (TGSIs) are physical barriers to persons with disabilities.

Placed obstacles make it difficult for a person with a disability to know where they are and where they are going and be confident about their orientation. These placed obstacles can create additional stress through the uncertainty of a person's safety along the direction of travel within a public built environment.

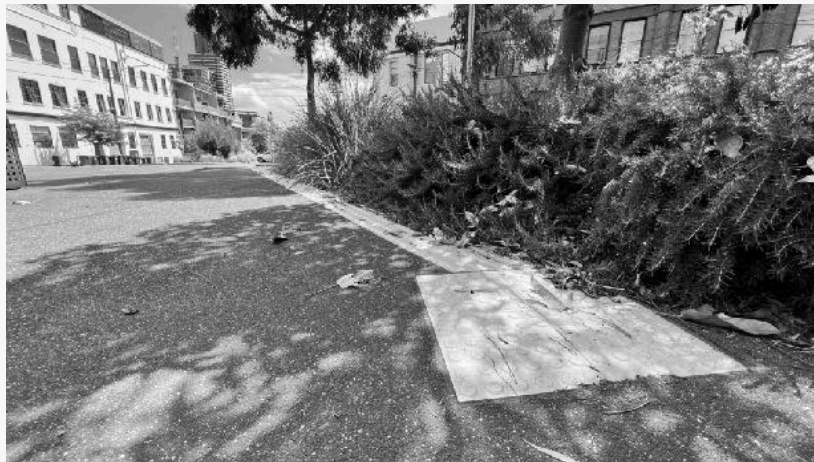
Example 3 Length: 3:28 mins

Overgrown vegetation disabling the utility of TGSIs

Greenery, overgrown shrubs or vegetation protruding into accessible paths of travel create mobility hazards for persons with disability. In particular, plants that have grown over mobility aids for a person with low vision, such as Tactile Ground Surface Indicators (TGSIs), cease to indicate or direct a person as they have become obscured and dangerous. Regular maintenance of green environments that border the perimeters of walkways requires programming to maintain the pathways as fit for purpose.

This video submission details the neglect of green maintenance, creating a barrier for a person with a disability.

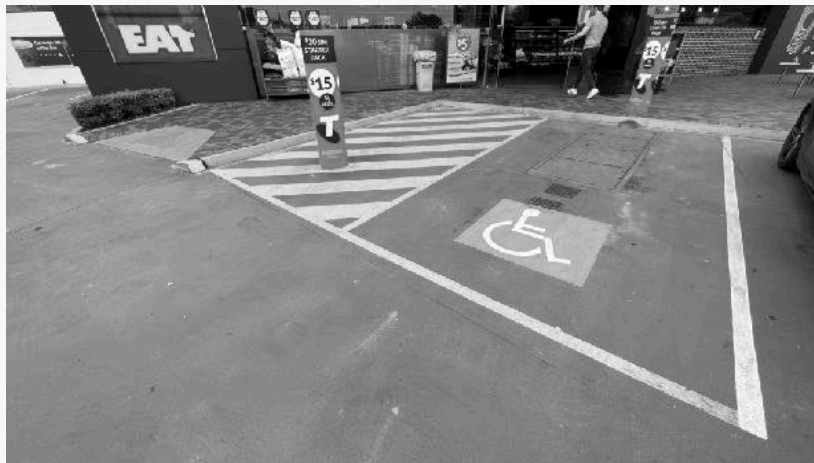
Example 4 Length: 2:03 mins

Signage obscuring disabled carpark pole

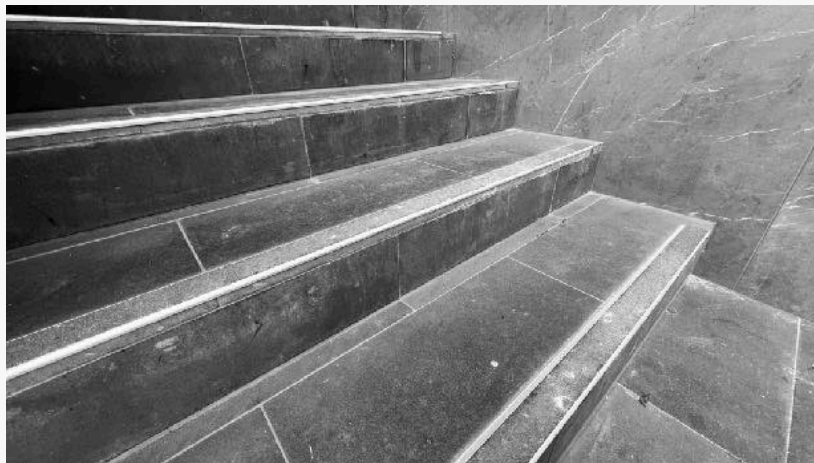
Example 5 Length: 3:48 mins

Luminance contrast between steps and edging

This video submission details stair nosing with the same light contrast as the step. An application of stair nosing that makes the edge of the step indistinguishable from that of the trafficable surface is an obstacle to a person's mobility and safety. The edge is obscured and undetectable. A person with low vision may be unable to use this stair as its design is confusing and hazardous.

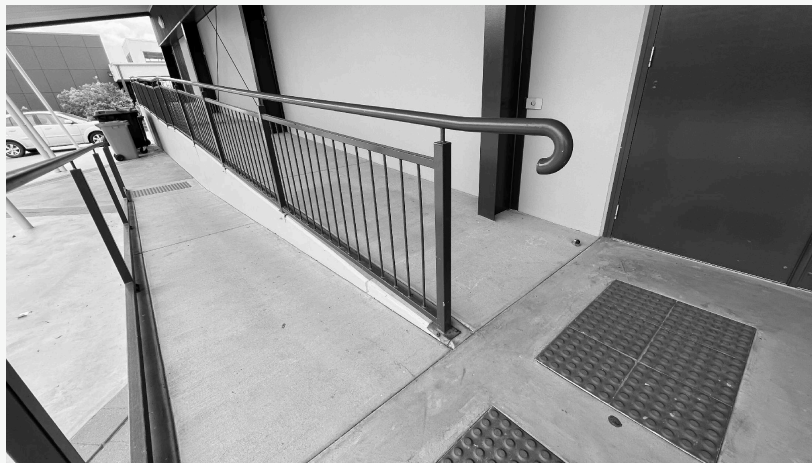
Example 6 Length: 3:09 mins

Wheelchair ramp with insufficient handrails

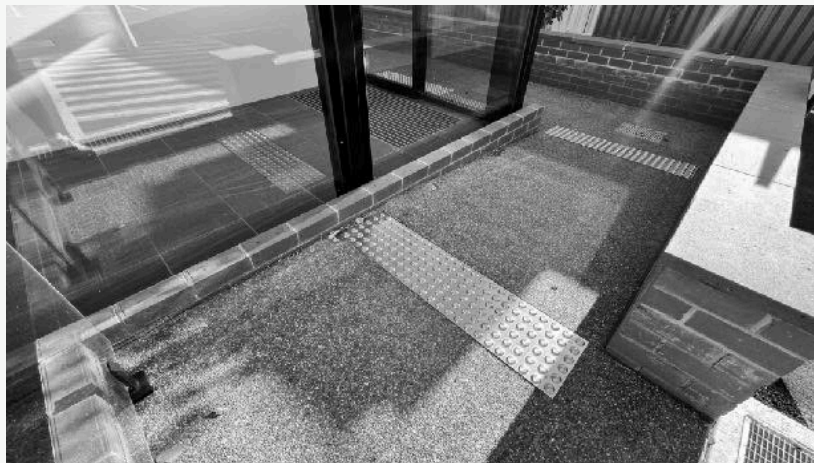
Example 7 Length: 3:23 mins

Access ramp with TGSIs too close to the hazard

This video submission details an experience where a tradesperson's competent skills meet the failure of instruction (or design) of where and how to install Tactile Ground Surface Indicators (TGSIs) at the top and bottom of an accessible entrance ramp into a health facility.

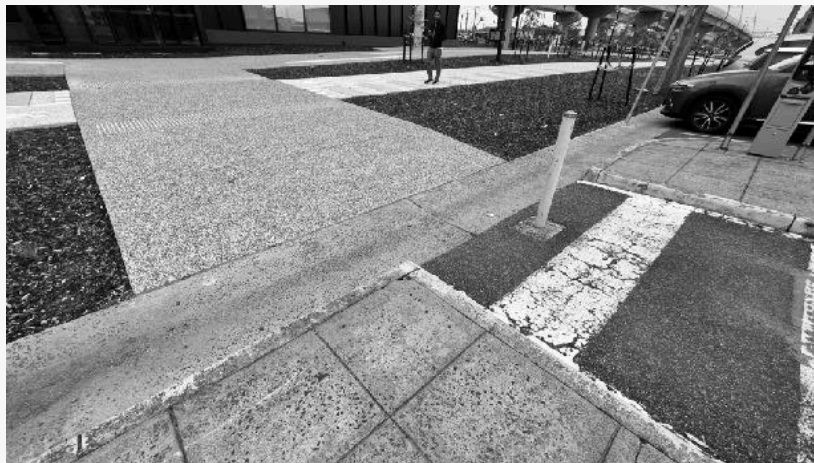
Example 8 Length: 3:25 mins

New accessibility makes existing access a hazard

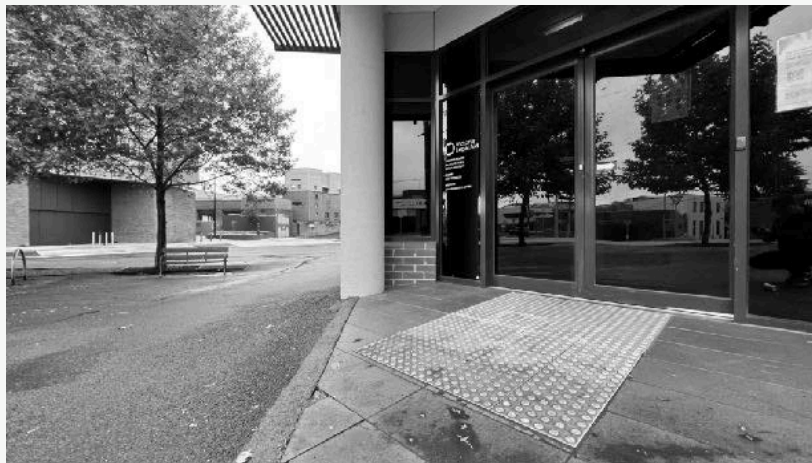
Example 9 Length: 2:11 mins

TGSIs used as a doormat at a building entrance

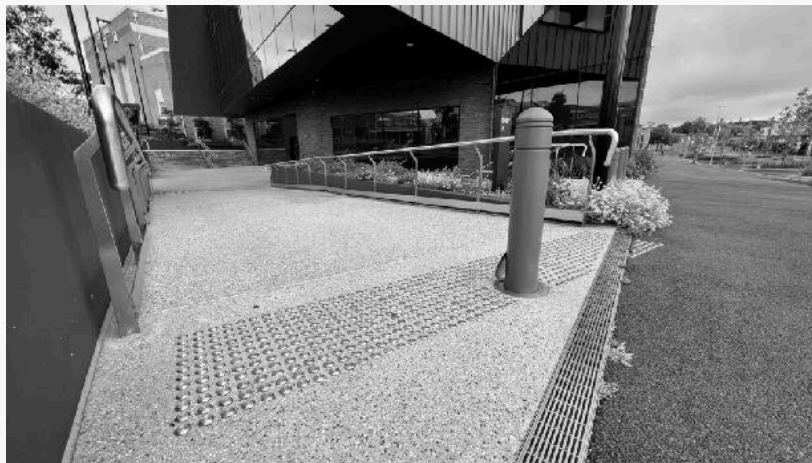
Example 10 Length: 4:47 mins

A ramp, a bollard, and an unsafe circulation space

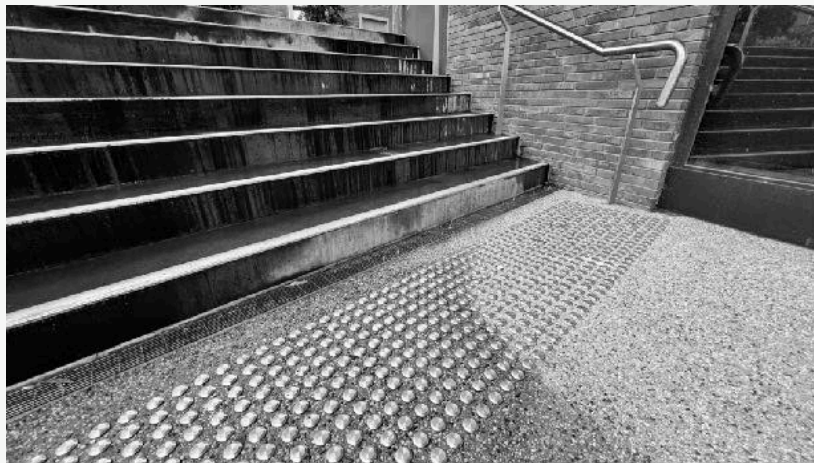
Example 11 Length: 2:41 mins

Changing luminance contrast in the wet & dry

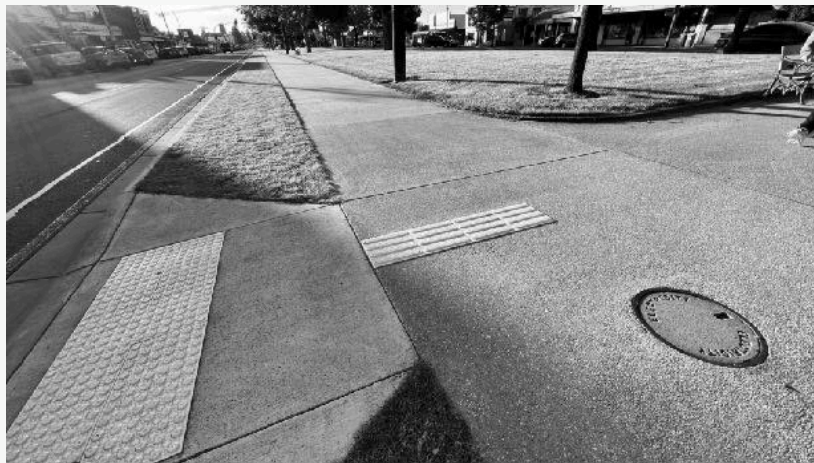
Example 12 Length: 2:56 mins

Insufficient amount of Directional TGSIs

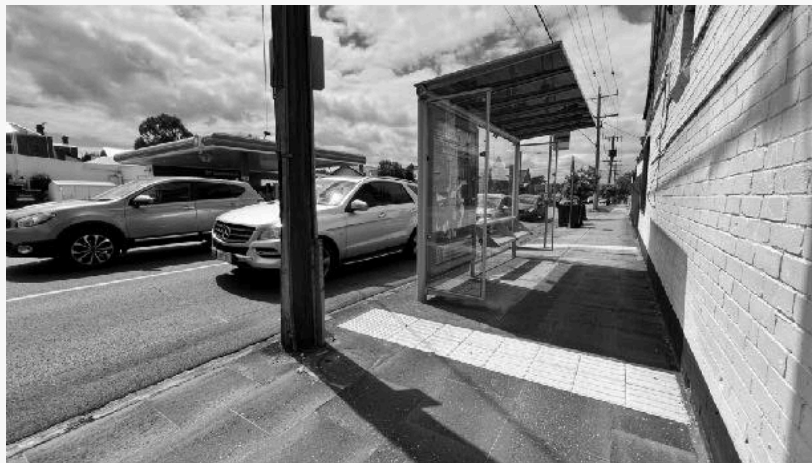
Example 13 Length: 4:43 mins

Upgraded bus stop makes TGSIs confusing

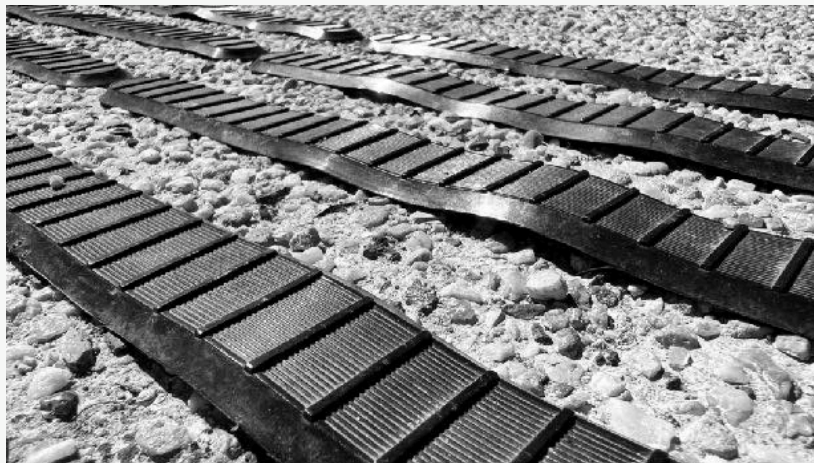
Example 14 Length: 3:42 mins

Product performance of TGSIs in hot weather

Knowledge and expertise in the application and installation of mobility aids are essential so as not to create any new hazards, obstacles or barriers. In the self-regulated industry of Disability Access, there is an absence of trained professionals, recognised learning and certified education pathways open to tradespersons. There is no legal or regulated training requirement for an installer of mobility aids, such as Tactile Ground Surface Indicators (TGSIs), so there is a fair amount of 'hit-or-miss' products, applications and installations.

This video submission details a lack of product knowledge and installation expertise, resulting in a tripping hazard with TGSIs. The TGSIs are also not level nor safely trafficable underfoot.

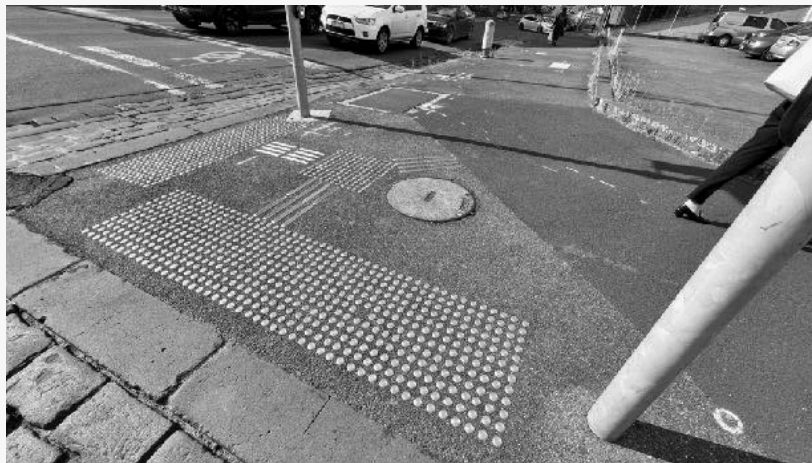
Example 15 Length: 4:15 mins

If TGSIs are removed, they must be replaced

This video submission details a replaced asphalt pedestrian walkway where the original Stainless Steel Directional TGSIs were once installed. A person with a disability who used to access these TGSIs can no longer do so. Their mobility and orientation needs have been neglected.

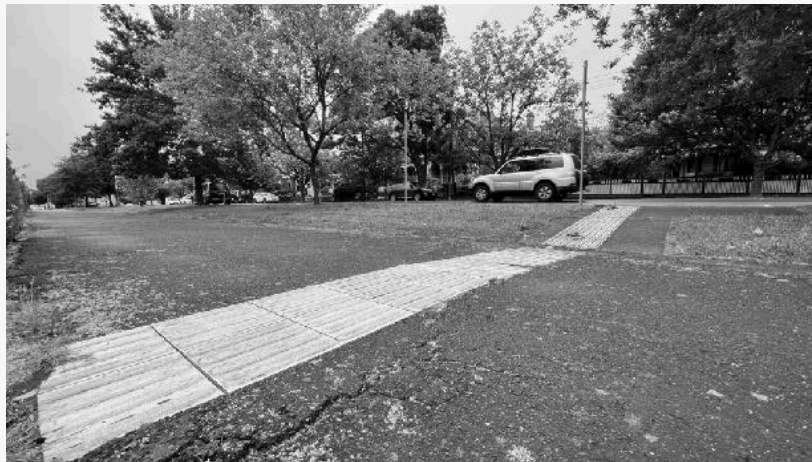
Example 16 Length: 2:08 mins

Gaps between TGSIs and their impact on mobility

Gaps more expansive than 10 millimetres between the ends of Directional Tactile Ground Surface Indicators (TGSIs) are not acceptable as specified in the Australian Standard. Gaps are allowed to accommodate drainage; however, voids, holes or, expansion joints greater than the prescribed amount can create other obstacles and hazards, such as dips, gaps, and loss of direction for a person with a disability such as low vision.

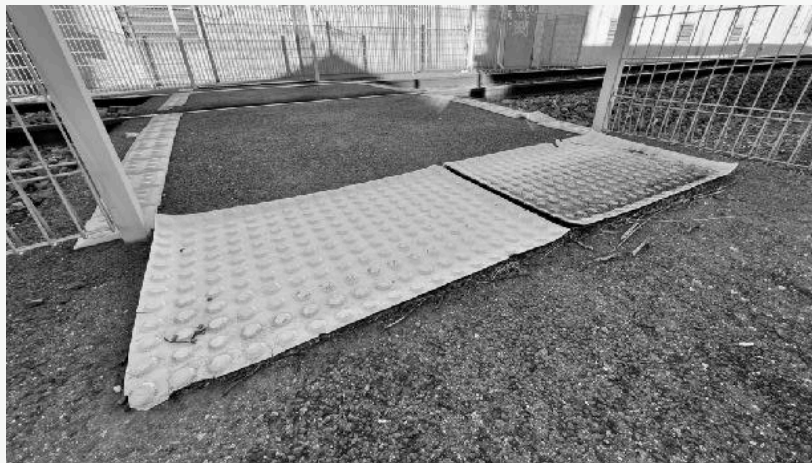
Example 17 Length: 3:14 mins

TGSI tripping hazard at a railway track crossing

How long should a mobility and orientation feature in the built environment remain fit for purpose? How can a product or feature's performance be determined when it depends on the application environment and its frequency of use? All materials degrade and lose functional integrity over time, but what is acceptable and who's checking?

This video submission details the performance of an Integrated Warning Tactile Ground Surface Indicator (TGSI) pad installed at a railway track crossing. It has long been unsafe and a tripping hazard. Is the material used in making the TGSI unit unfit for the intended application?

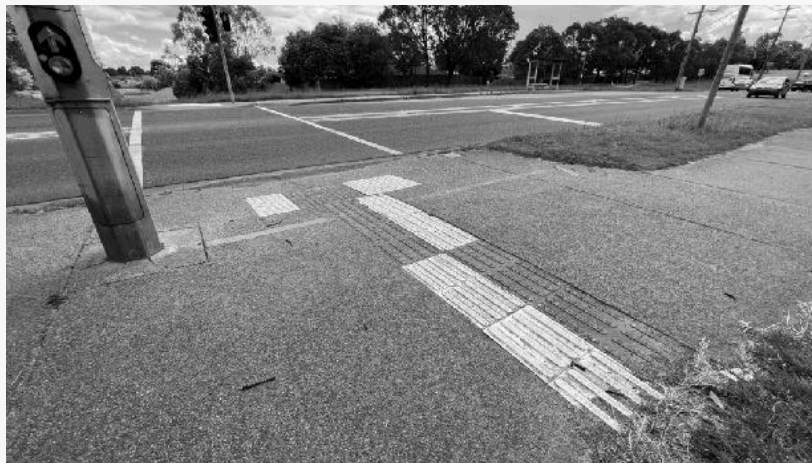
Example 18 Length: 4:42 mins

Non-conforming multi-coloured TGSIs

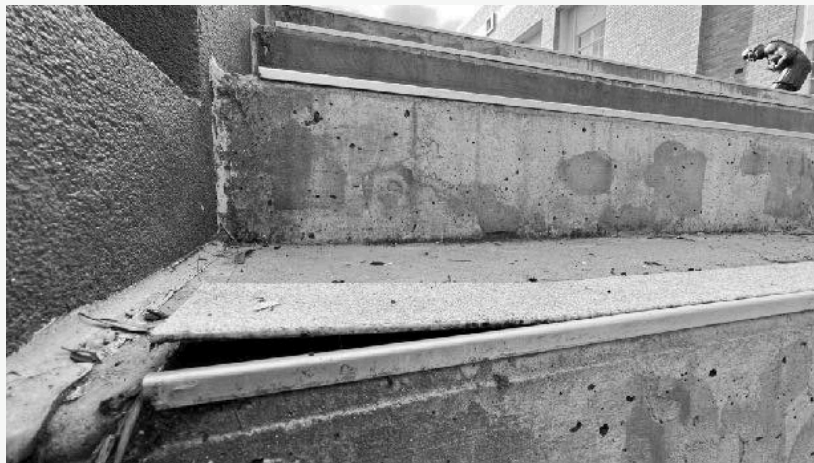
Example 19 Length: 3:42 mins

Stair trim product design unfit for purpose

Mobility aids designed to visually delineate the edge of hazard, a product such as stair nosing, are required to be safe in their design. This requirement includes the material, the manufacturing method and the specified installation technique necessary for a mobility aid like this to decrease the probability of harm or injury to a person with a disability.

This video submission details a stair nosing product that has had a low performance in an external wet and dry environment, potentially causing a new obstacle for a person with a disability. Neglect and a proactive duty of care are absent in as much that a relatively new product has not been fixed or replaced or a warranty claimed.

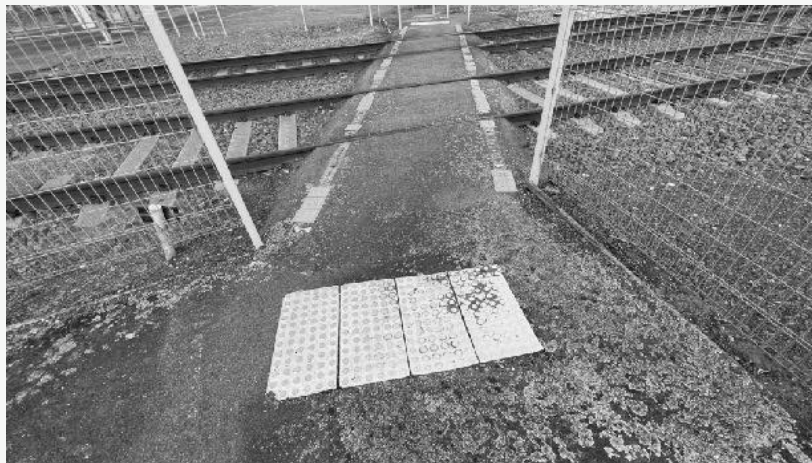
Example 20 Length: 5:22 mins

Pedestrian maze track crossing

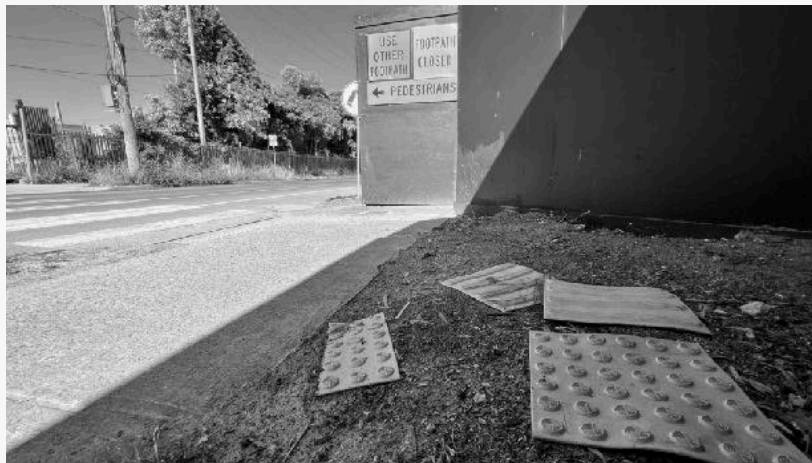
Example 21 Length: 3:53 mins

Temporary products for temporary accessibility

This video submission details a project where barrier-free access was provided for a person with a disability. However, over six months, it has degraded, disassembled and no longer provides access. The result is a patchwork of TGS products and signs confusing a person with a disability.

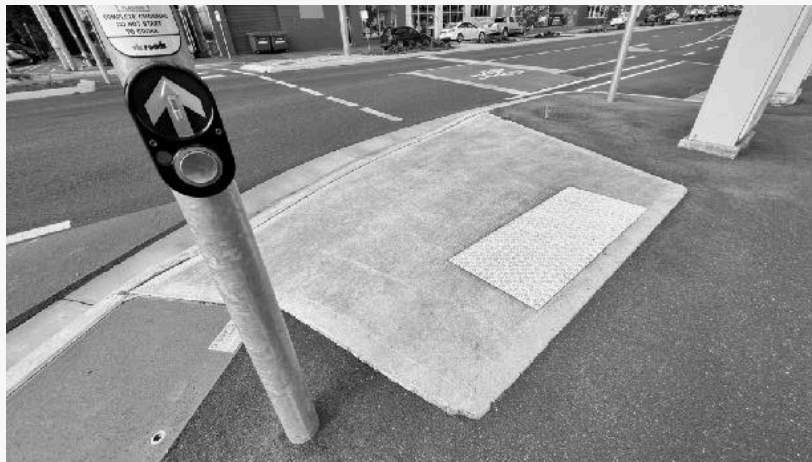
Example 22 Length: 3:56 mins

The danger of TGSIs if Standards are ignored

What happens when professionals become ignorant of Standards and fail to use jurisdictional guidelines that provide accessibility, orientation and mobility instruction? The design and implementation become inconsistent, confusing and, at worst, dangerous to a person with a disability.
